NATIONAL TRANSPORTATION SAFETY BOARD

Group Chairman's Factual Report

OPERATIONAL FACTORS

ANC21FA069

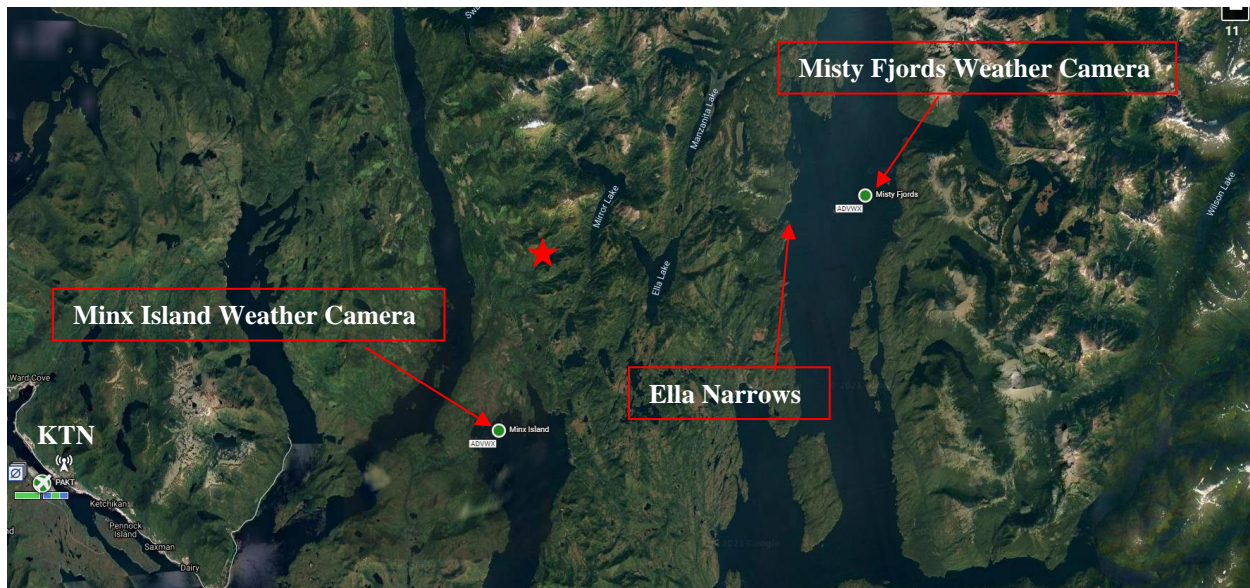
Figure 1: Location of the Misty Fjords and Minx Island weather cameras (red star indicates approximate location where accident occurred).

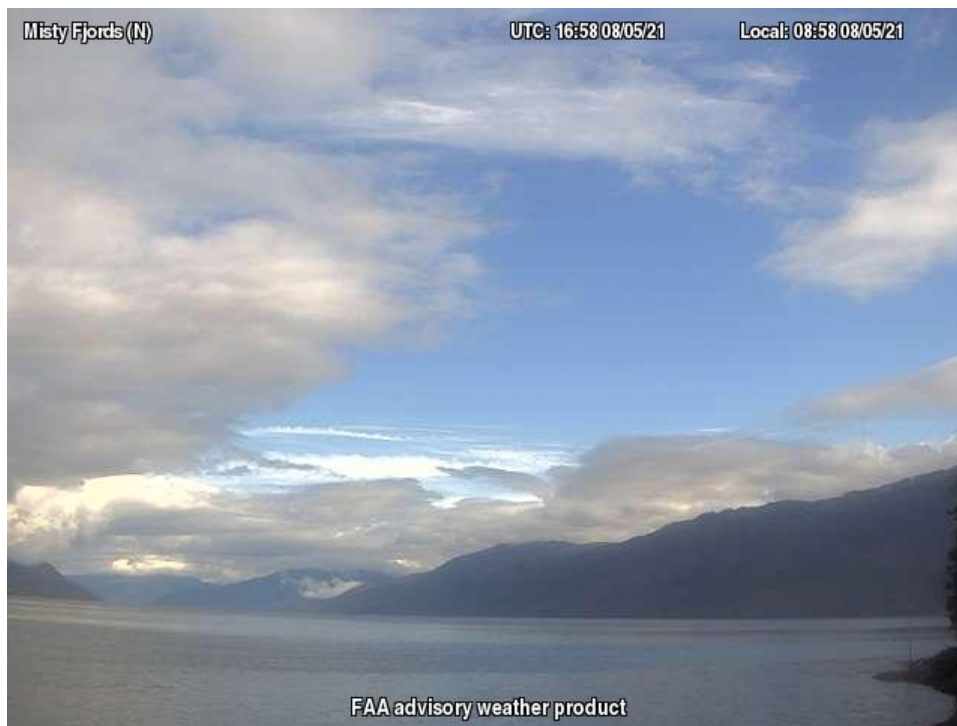
Photo 1: Misty Fjords weather camera looking north up the Behm Canal at 0858.

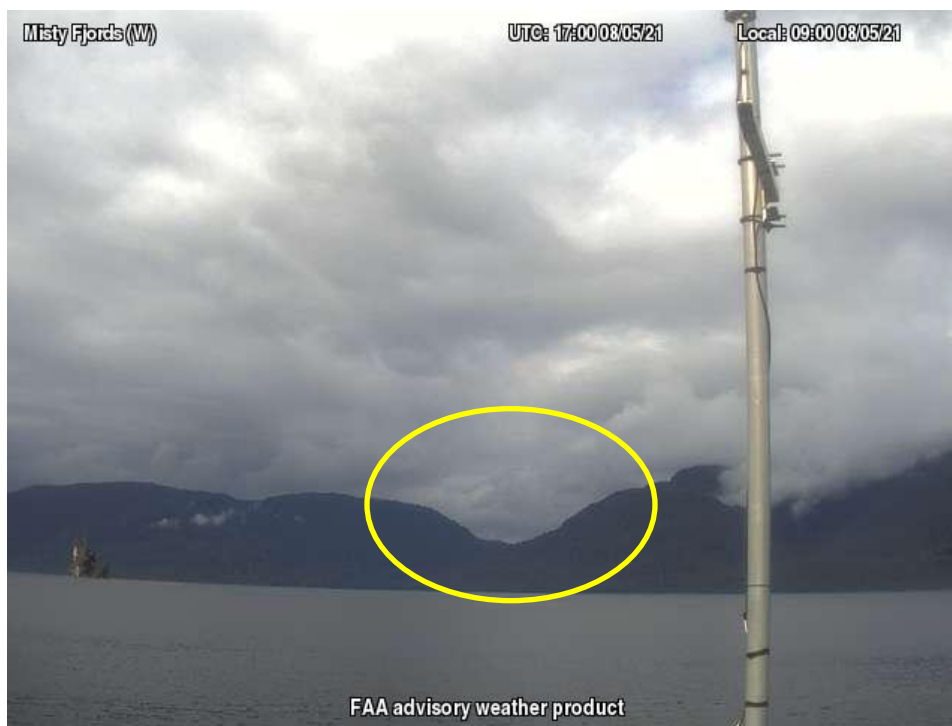
Photo 2: Misty Fjords Camera looking west toward the Ella Narrows (indicated by yellow circle) at 0900.

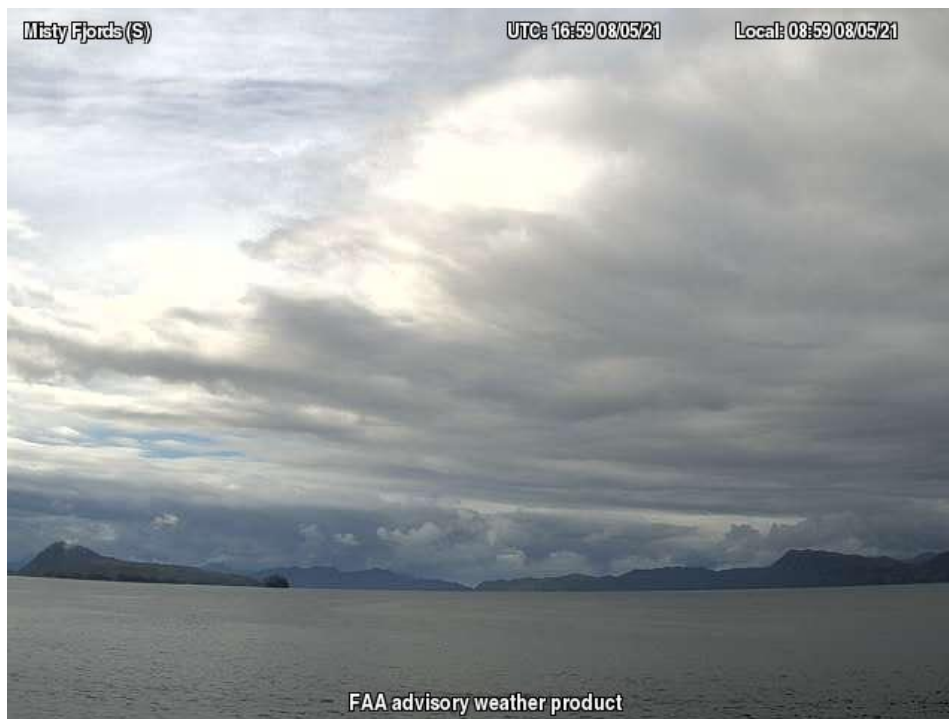
Photo 3: Misty Fjords Camera looking south down the Behm Canal at 0859.

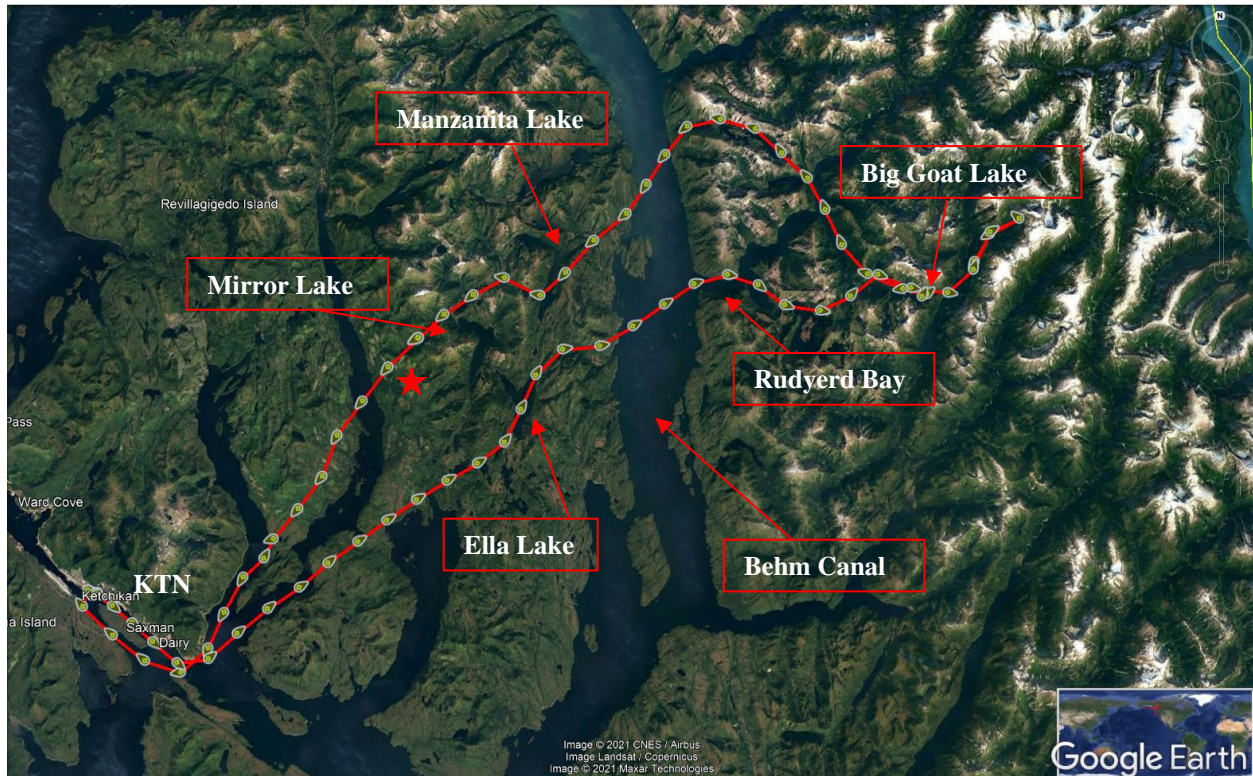
Figure 2: Spidertracks image of N1249K first flight on August 5, 2021. Red star indicates the approximate location of the accident site on the second Misty Fjords flight.

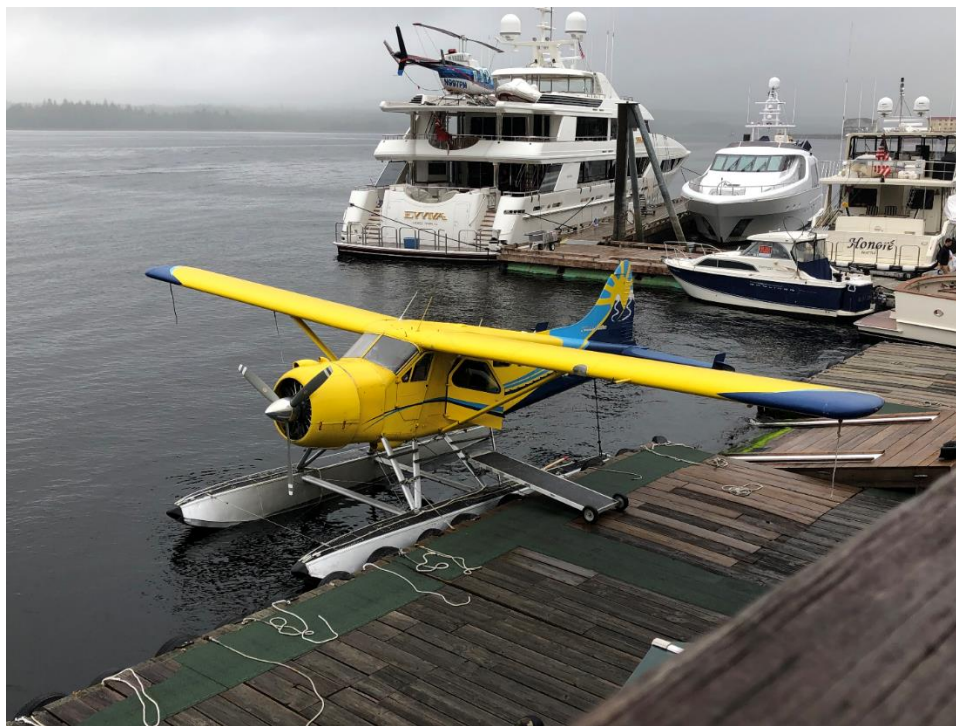
Photo 10: Photo of N1249K taken prior to departure on the accident flight, August 5, 2021.⁴⁸

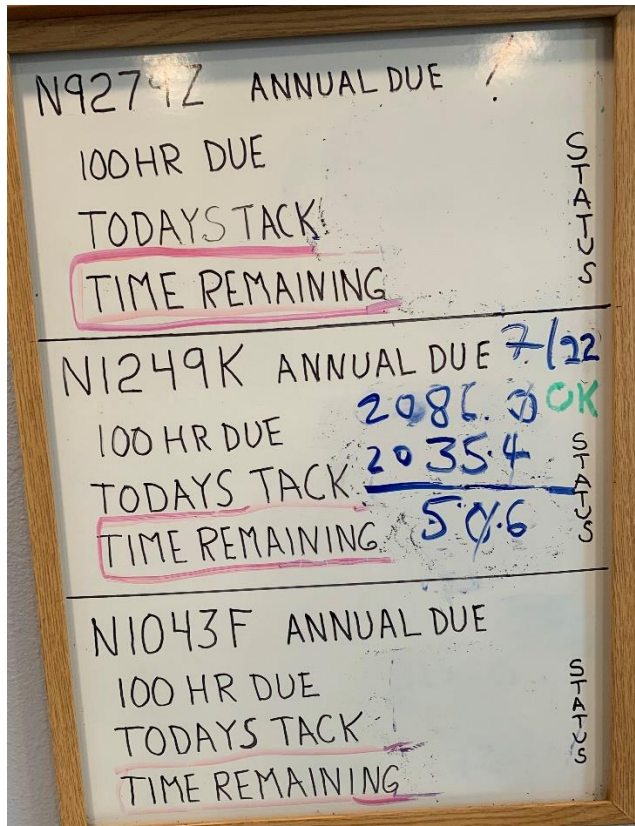
The airplane was registered to Snow Mountain Enterprises LLC of Ketchikan, Alaska, and the registered agent was the Southeast Aviation LLC owner's spouse. It was operated by Southeast Aviation LLC as a 14 *CFR* Part 135 commercial air tour. According to a "white board" located at the Southeast Aviation LLC office, N1249K had an annual inspection due "7/22," a 100-hour inspection due at 2,086.0 tachometer hours, and the current tachometer reading was shown as 2,035.6 hours.⁵¹

Photo 11: Aircraft information board at Southeast Aviation offices.⁵²

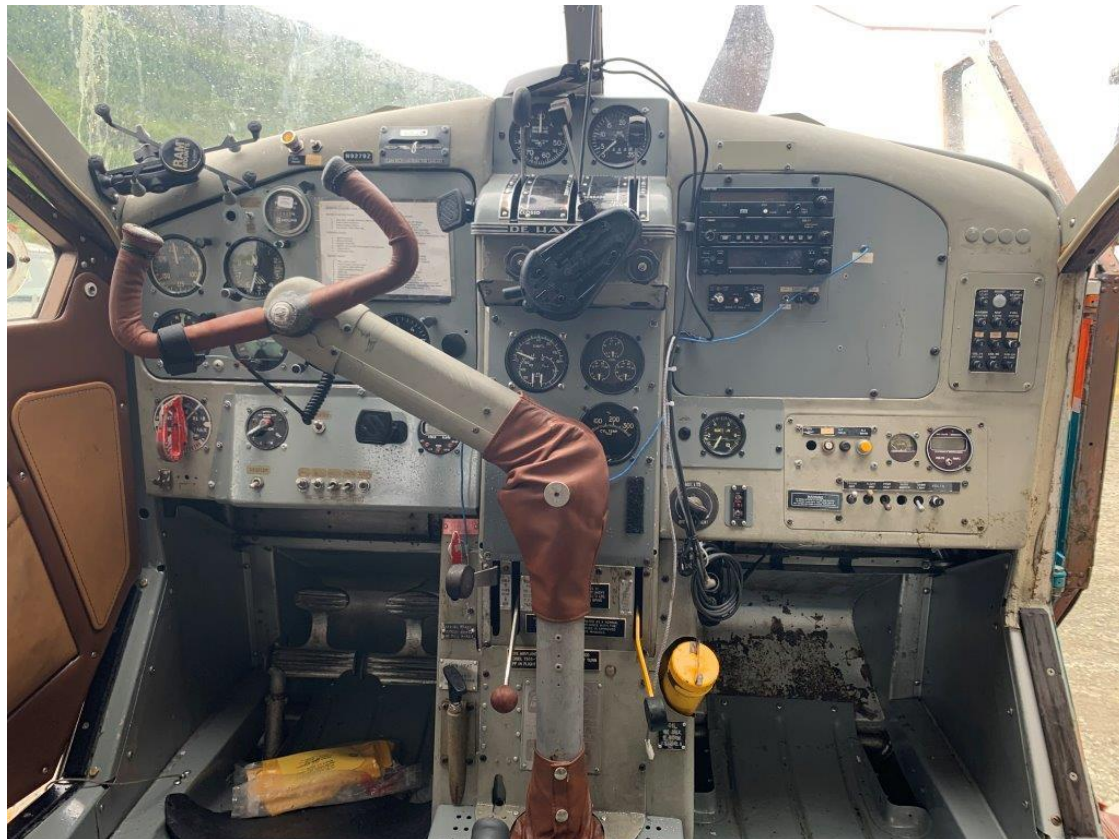
Photo 12: Exemplar DHC-2 cockpit panel (N9279Z) operated by Southeast Aviation and involved in a July 9, 2021 accident, flown by the accident pilot.⁵⁵
